**SUSQUEHANNA RIVER BASIN
GENEGANTSLET LAKE DAM**

**CHENANGO COUNTY, NEW YORK
INVENTORY NO. N.Y. 846**

**PHASE I INSPECTION REPORT
NATIONAL DAM SAFETY PROGRAM**

Name of Dam: Genegantslet Lake Dam (I.D. NY 846)
State Located: New York
County : Chenango
Watershed: Susquehanna River Basin
Stream: Unnamed tributary of Genegantslet Creek
Date of Inspection: October 22, 1980

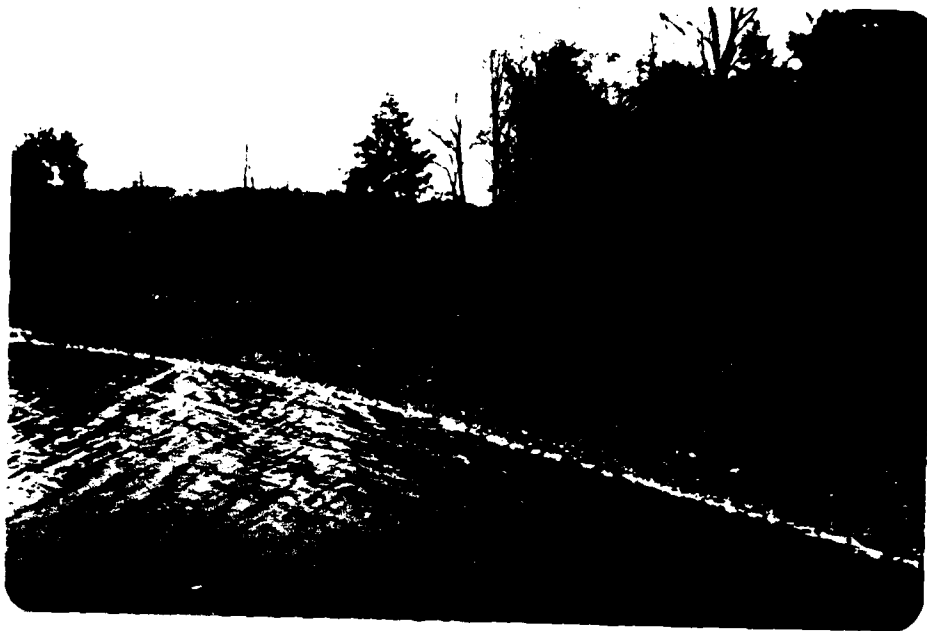
Crest of embankment
